November 12, 2020

Re: *Devil's Gate Reservoir Restoration Project – Phase 1 Restoration Qualitative Monitoring Conducted on October 7, 2020*

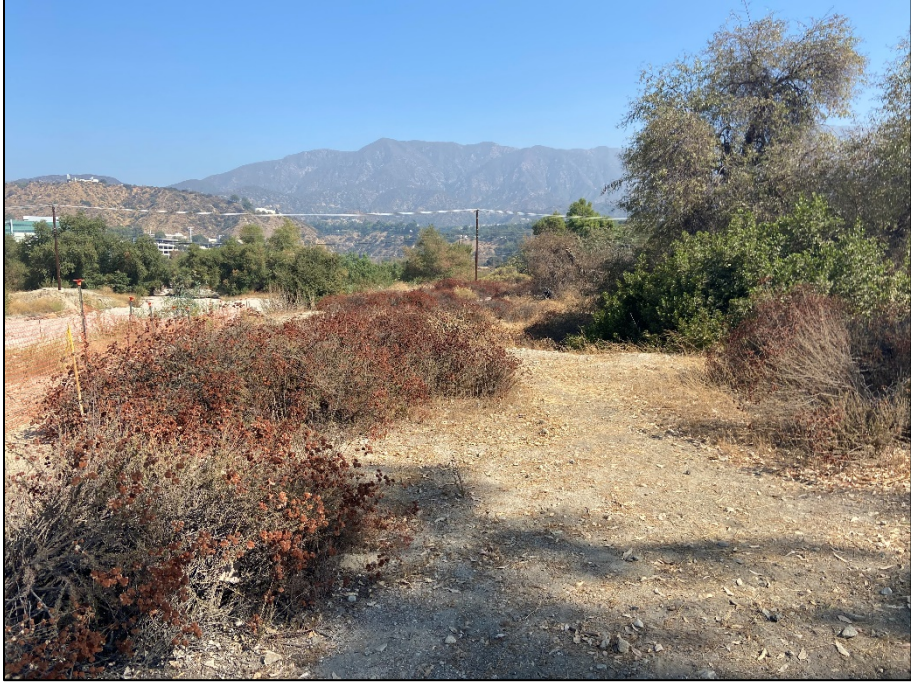
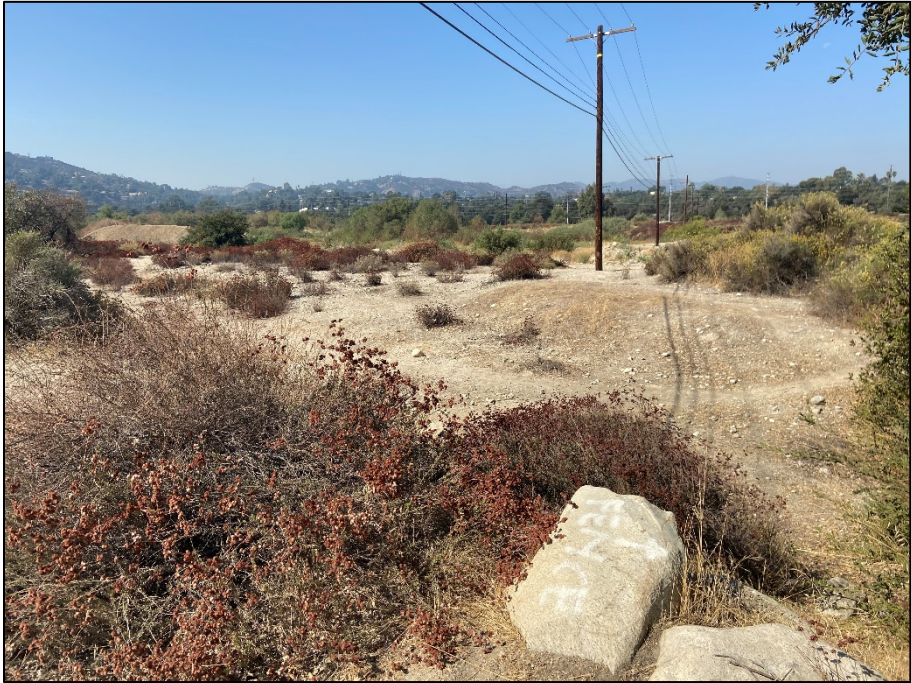
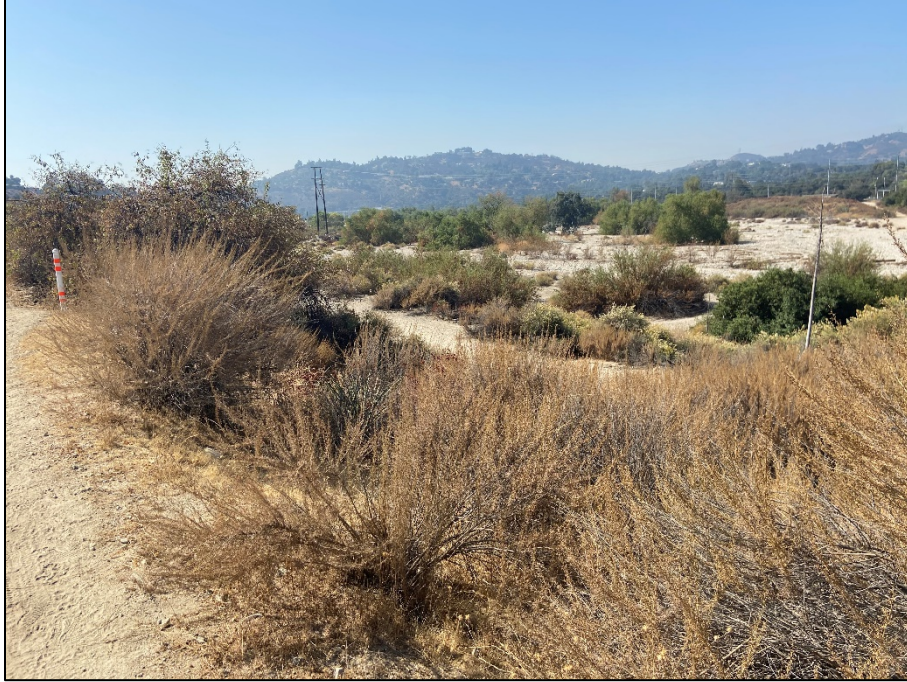
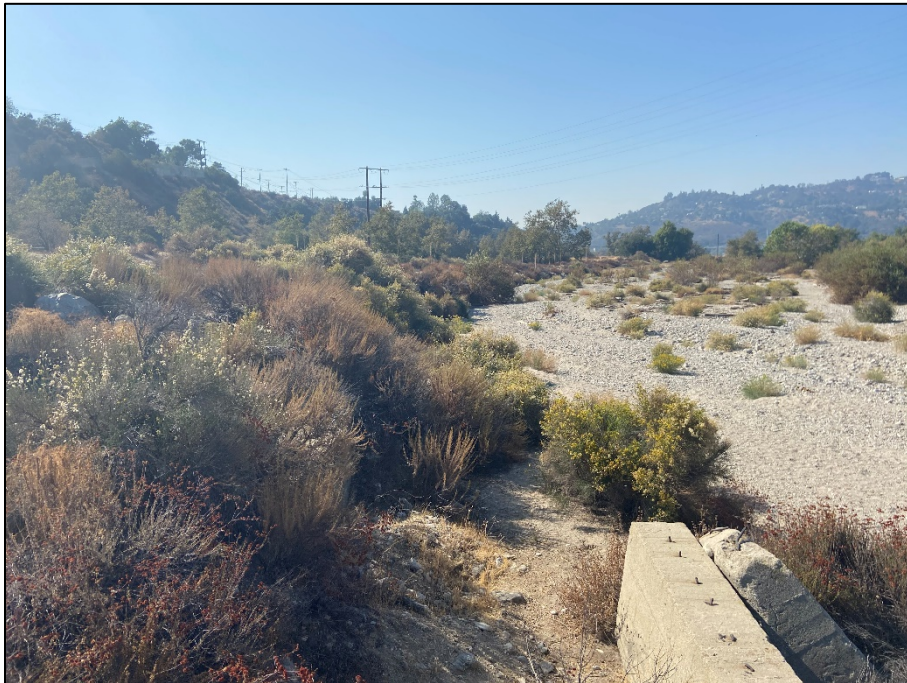
Container plants were not installed in the DG-1 or DG-1 WOUS mitigation areas, but these areas were seeded with native plant species. Native plant growth was noted throughout the DG-1 and DG-1 WOUS mitigation areas, likely both from natural recruitment and from seeding; however, germination was observed to be very minimal in the majority of these mitigation areas. Native germination was found to be higher closer to the reservoir in DG-1 where seed likely dispersed due to water flow. Portions of DG-1 WOUS were noted as being scoured during the wet season and had minimal plant growth. Native plants such as annual bursage (*Ambrosia acanthicarpa*), California sagebrush (*Artemisia californica*), Canada horseweed (*Erigeron canadensis*), California buckwheat (*Eriogonum fasciculatum*), common sandaster (*Corethrogyne filaginifolia*), and California everlasting (*Pseudognaphalium californicum*) were observed sprouting in the DG-1 and DG-1 WOUS mitigation areas. In addition, dodder (*Cuscuta sp.*) was observed growing on some of the shrubs in this mitigation area, which could lead to future decline of these shrubs; however, the dodder was noted as being mostly dead. Photos 1 through 4 in Attachment B document the mitigation area during the monitoring visit.

Nonnative weed cover in DG-1 and DG-1 WOUS was estimated at approximately <1 percent, if the dead annual weeds are excluded, which is approximately 9 percent less than the level of weed cover that was observed during the previous qualitative monitoring event. Nonnative species observed in DG-1 and DG-1 WOUS included wild oat (*Avena fatua*) black mustard (*Brassica nigra*), red brome (*Bromus madritensis ssp. rubens*), tocalote (*Centaurea melitensis*), and Indian plantain (*Plantago arenaria*); however, most individuals were observed to be dead for the season.

Photo 1: Overview Mitigation Area DG-1

Photo 2: Overview Mitigation Area DG-1

Photo 3: Overview Mitigation Area DG-1

Photo 4: Overview Mitigation Area DG-1 WOUS

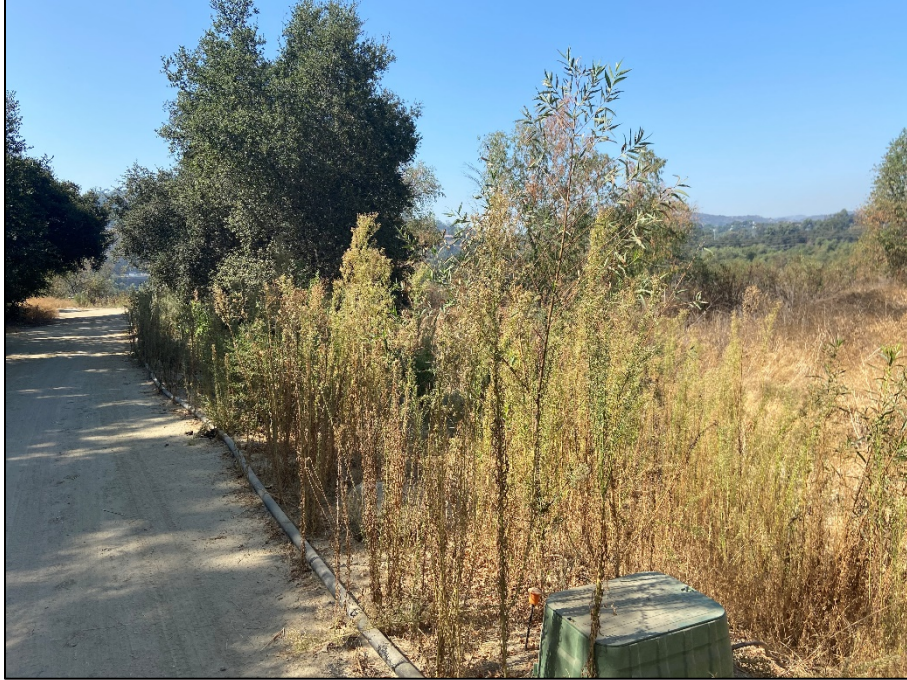
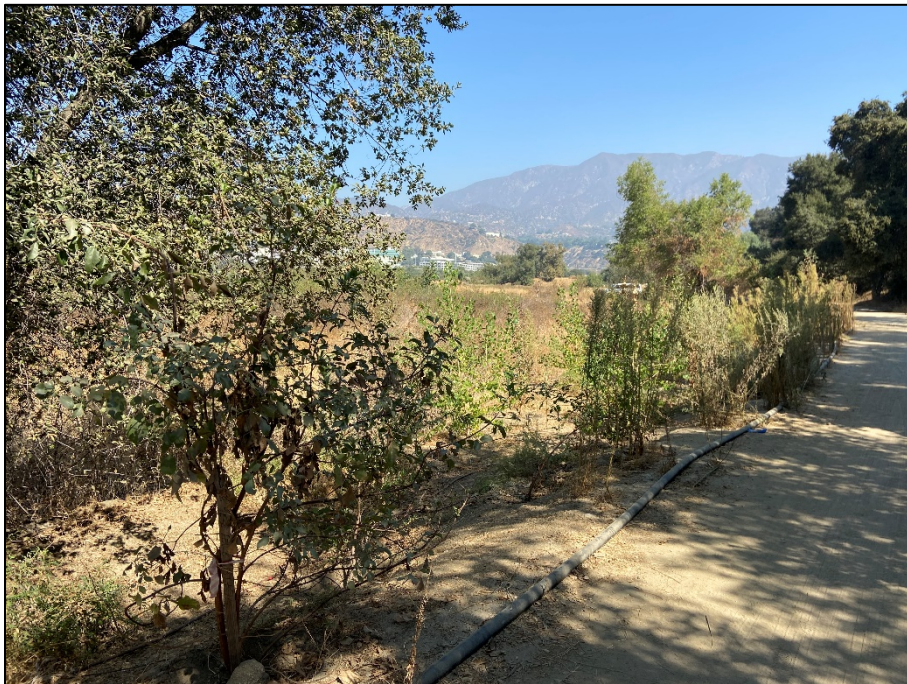
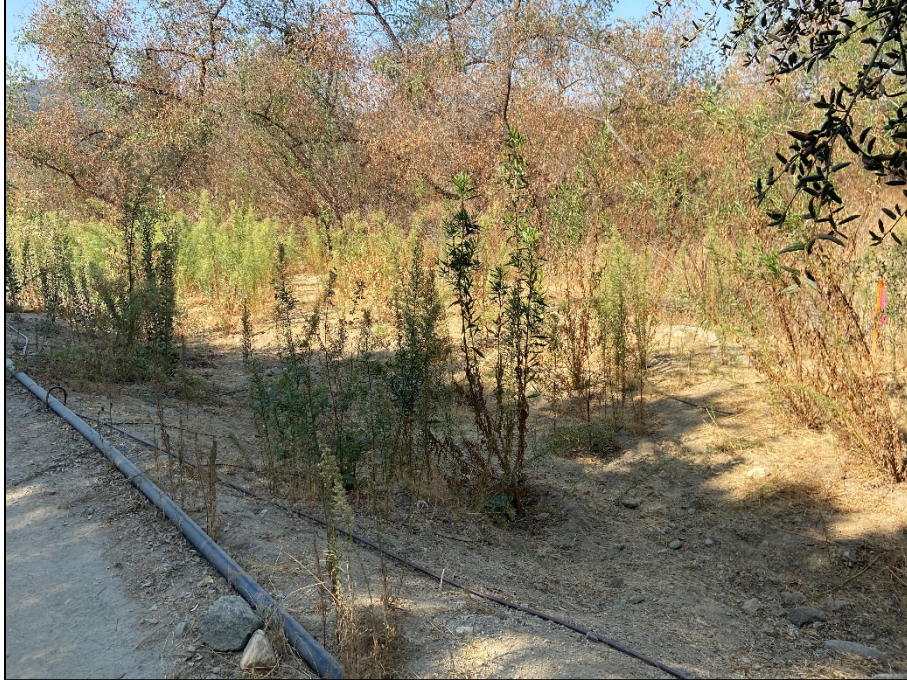
The overall health of the container plants in DG-2A was noted as being good. Approximately 10 percent of all container plants were showing varied levels of stress, which is the same percentage of plants that

were showing stress during the previous qualitative monitoring event. Stress may be occurring as a result of 1) drought stress from recent high temperatures, 2) herbivory by rabbits or other wildlife, or 3) competition from nonnative and invasive weeds. A negligible number of container plants were noted as being missing or dead. Formal mortality counts were taken for DG-2A during the quantitative monitoring and will be included in the annual reporting. The willow species (*Salix sp.*) in the mitigation areas were starting to show signs of seasonal dieback. The installation of plants in the DG-2A mitigation area appears to have been completed successfully. The current issues identified during the monitoring visit are not expected to have an effect on the continued growth of the plants in the mitigation area. Photos 5 through 7 in Attachment B document the mitigation area during the monitoring visit.

Nonnative weed cover in DG-2A was estimated at approximately <1 percent, if the dead annual weeds are excluded, which is approximately 4 percent less than the level of weed cover that was observed during the previous qualitative monitoring event. Nonnative species observed in DG-2A included black mustard.

Photo 5: Overview Mitigation Area DG-2A

Photo 6: Overview Mitigation Area DG-2A

Photo 7: Overview Mitigation Area DG-2A

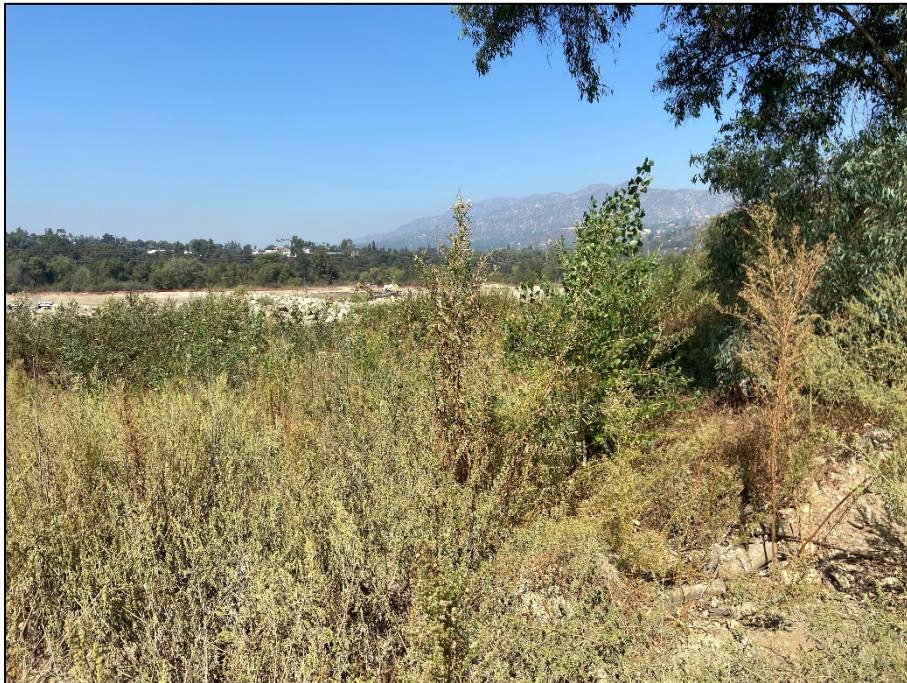
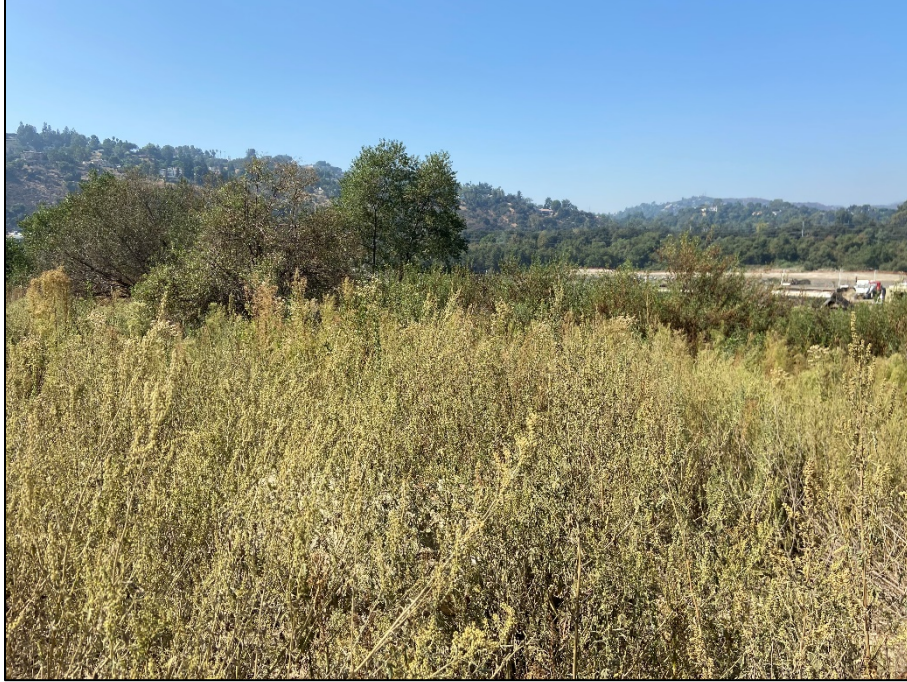
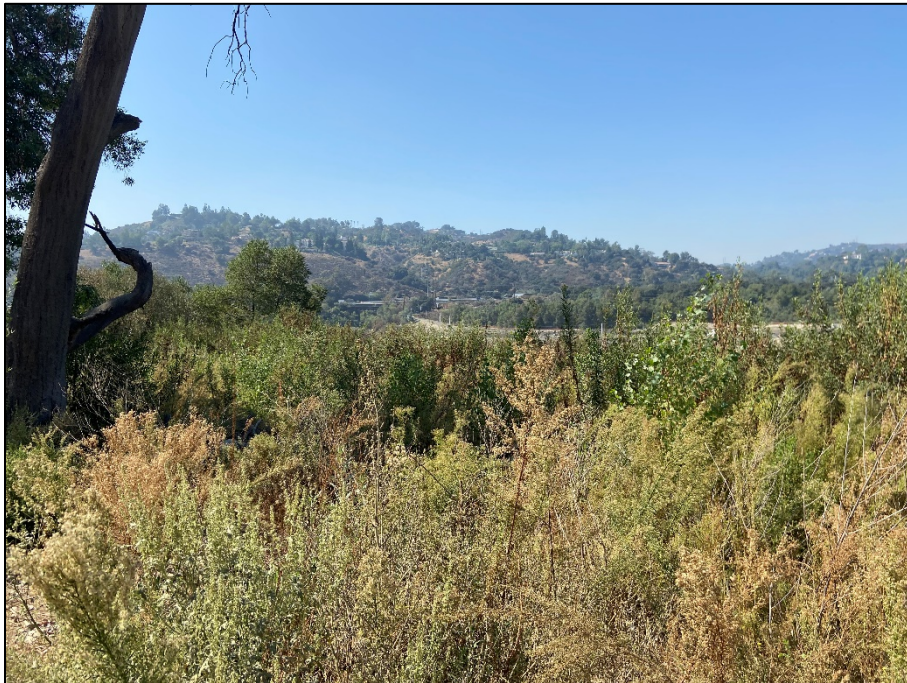
The overall health of the container plants in DG-2B was noted as being good. Approximately 10 percent of all container plants were showing varied levels of stress, which is 5 percent less than the percentage of plants that were showing stress during the previous qualitative monitoring event. Stress was likely due to the same reasons as those described for DG-2A; however, recent high temperatures appeared to be the most common cause of stress. In addition, insect galls were observed on several of the willow species. Formal mortality counts were taken for DG-2B during the quantitative monitoring and will be included in the annual reporting. Similar to DG-2A, the willow species were beginning to show signs of seasonal dieback. The installation of the plants in the DG-2B mitigation area appears to have been successfully completed. The current issues identified during the monitoring visit are not expected to have an effect on the continued growth of plants in the mitigation area. Photos 8 through 10 in Attachment B document the mitigation area during the monitoring visit.

Native plant growth was noted throughout the DG-2B mitigation area, likely both from natural recruitment and from seeding. Native plants such as annual bursage, mulefat, Canada horseweed, telegraph weed, and stinging nettle were observed sprouting in the DG-2B mitigation area. In addition, dodder was observed growing on some of the shrub and tree species in this mitigation area which could lead to future decline of these shrubs; however, the dodder was observed to be mostly dead for the season.

Nonnative weed cover in DG-2B was estimated at approximately <1 percent, if the dead annual weeds are excluded, which is approximately 4 percent less than what was observed during the previous qualitative monitoring event. Nonnative species observed in DG-2B included black mustard and perennial pepperweed (*Lepidium latifolium*); however, most black mustard individuals were observed to be dead for the season.

Photo 8: Overview Mitigation Area DG-2B

Photo 9: Overview Mitigation Area DG-2B

Photo 10: Overview Mitigation Area DG-2B

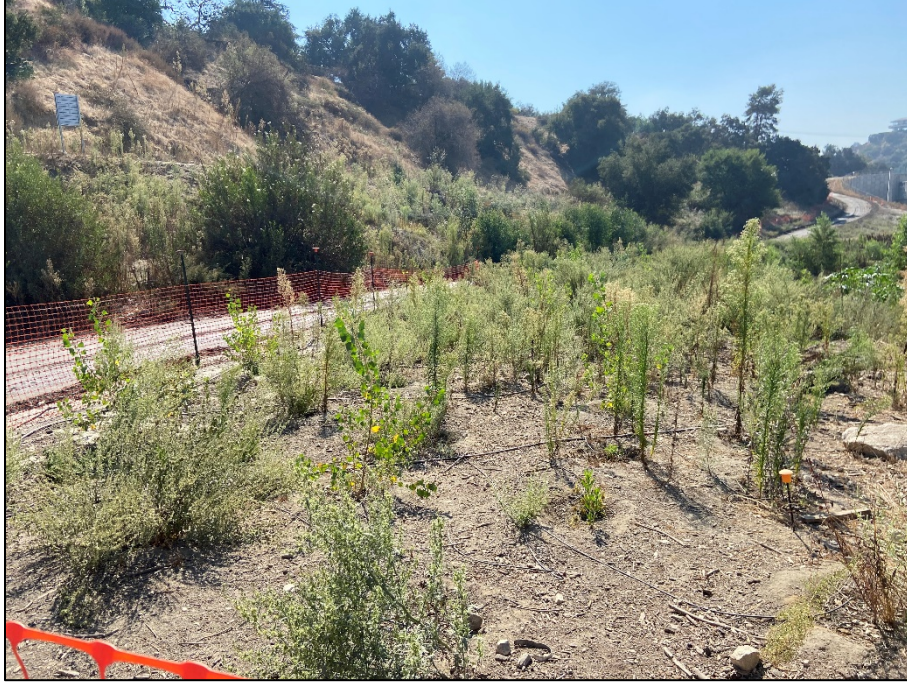
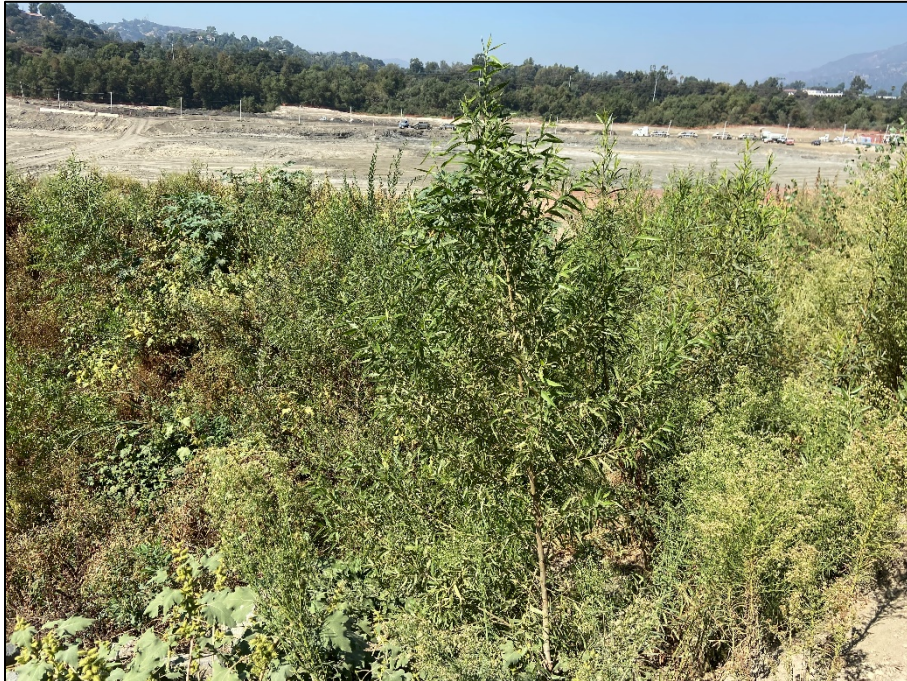
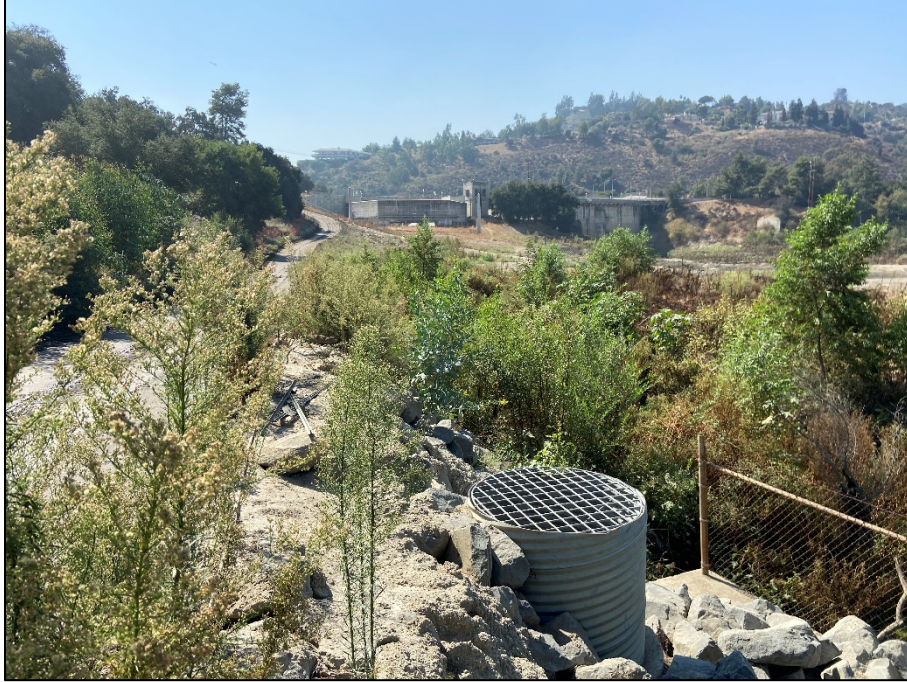
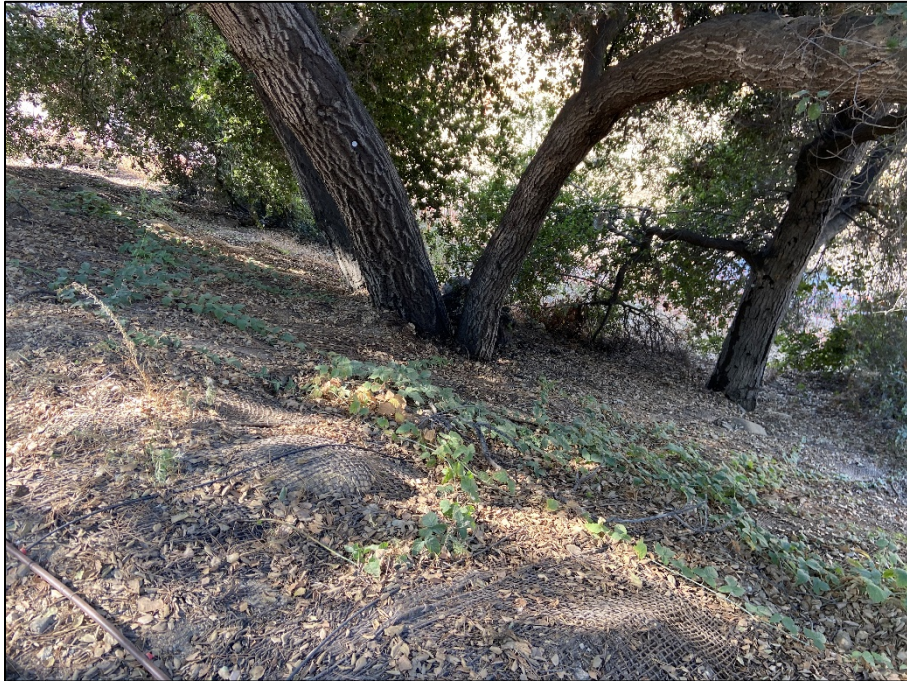
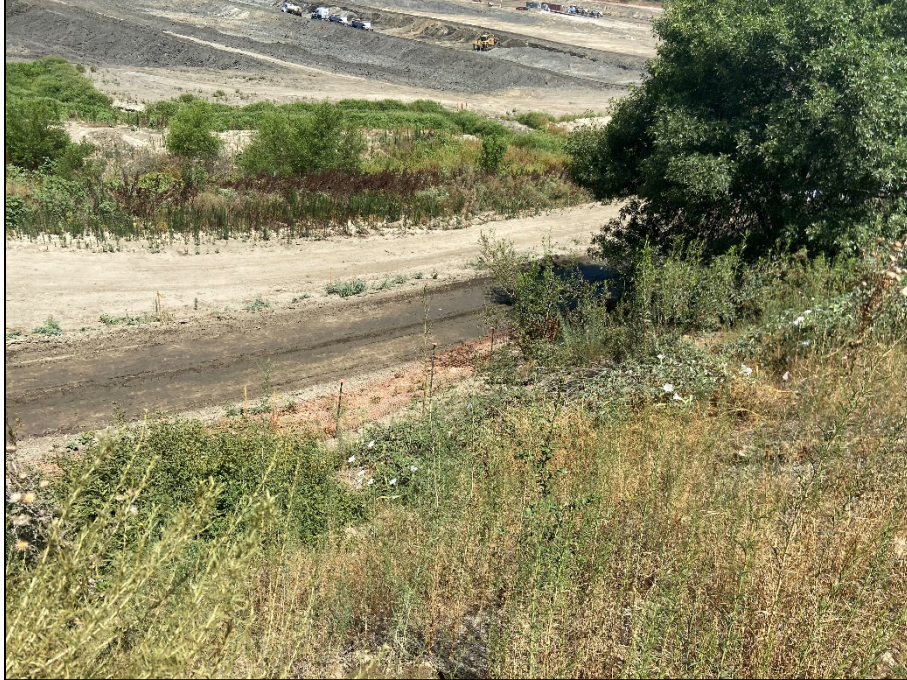
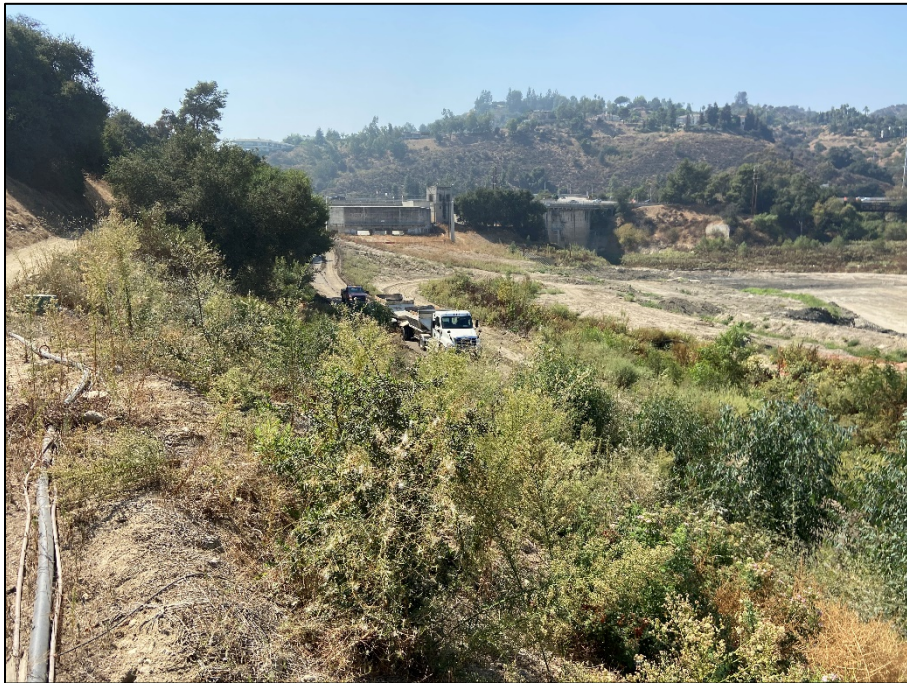
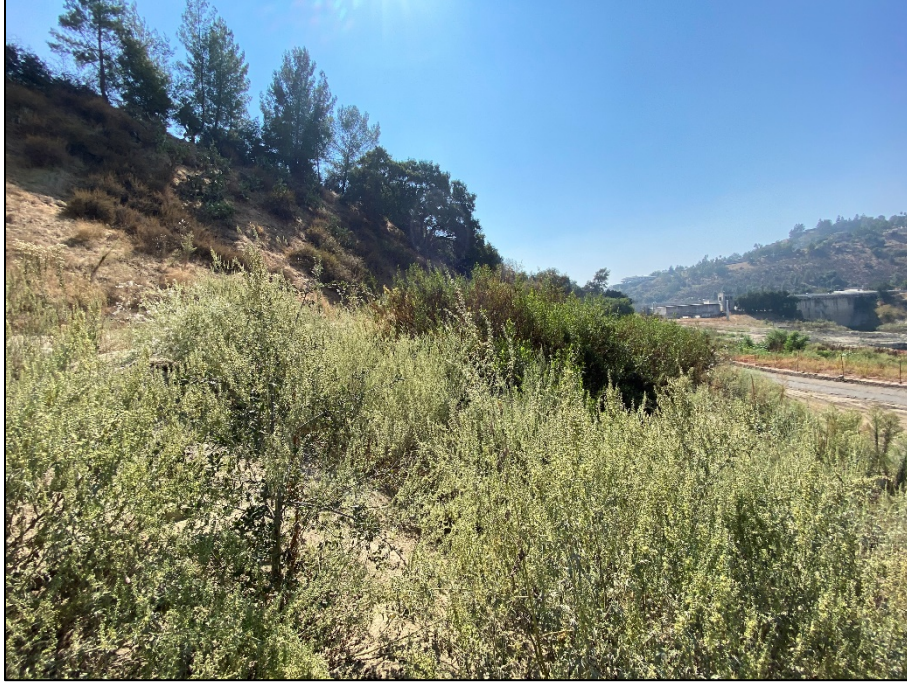
The overall health of the container plants in DG-3A was noted as being good. Approximately 20 percent of the container plants in the Coast Live Oak Woodland portions of DG-3A were noted as showing varied levels of stress, which is the same number of plants that were showing stress during the previous qualitative monitoring event. Approximately 10 percent of the container plants in the Mulefat Thickets portions of DG-3A were noted as showing varied levels of stress, which is approximately 5 percent less than the number of container plants that were showing stress during the previous qualitative monitoring event. Formal mortality counts were taken for DG-3A during the quantitative monitoring and will be included in the annual reporting. The types of stress the plants were exhibiting are the same as those described for the plants in DG-2A. However, erosion is also a problem in some areas of DG-3A. In addition, the heavy water and debris flows noted during previous monitoring visits have contributed to plant mortality and stress in this mitigation area. Similar to DG-2A, the container planted willow species were starting to show seasonal dieback; however, the planted willow and mulefat cuttings were observed to be sprouting vigorously. During the monitoring visit, the planted coast live oak (*Quercus agrifolia*) acorns were inspected for survivorship and health. Approximately 20 germinated coast live oak acorns appear to still be present in DG-3A. The majority of the germinated acorns appear to be in good health; however, several appeared to be showing signs of drought stress. One large existing coast live oak tree was observed to have branch failure that fell into the DG-3A mitigation area. It was not clear if the failed branch was crushing container plants due to the visual buffer created by the branch. The installation of the plants in the DG-3A mitigation area appears to have been completed successfully. The current issues noted during the monitoring are not expected to have a negative effect on the continued growth of the plants in the mitigation area. Photos 11 through 17 in Attachment B document the mitigation area during the monitoring visit.

Nonnative weed cover in DG-3A was estimated at approximately <5 percent, if the dead annual weeds are excluded, which is approximately 5 to 10 percent less than what was observed during the previous qualitative monitoring event. Nonnative species observed in DG-3A included black mustard, perennial pepperweed, tree tobacco (*Nicotiana glauca*), and castor bean (*Ricinus communis*). In addition, vigorous growth was observed sprouting from the stumps of the eucalyptus trees (*Eucalyptus sp.*).

Erosion in the Phase 1 mitigation areas was only observed in DG-3A and was minor in severity. Due to the steepness of the slope in the Coast Live Oak Woodland portion of the DG-3A mitigation area, erosion will likely continue to be somewhat of an issue in this area; however, jute nettings are currently in place on the slope and will help to lessen the severity of erosion issues. As native cover increases in this area, erosion issues should lessen. The severity of the erosion should continue to be monitored in all planted areas and if warranted, erosion Best Management Practices (BMPs) should be installed in appropriate areas. This may only require the installation of straw wattles at select sites to prevent existing rills from becoming larger. However, until more native perennial plants become established in these areas, there is the potential that intense rainfall may create additional erosion problems.

Photo 11: Overview Mitigation Area DG-3A Alta Dena Drain

Photo 12: Overview Mitigation Area DG-3A Alta Dena Drain

Photo 13: Overview Mitigation Area DG-3A Alta Dean Drain

Photo 14: Overview Mitigation Area DG-3A Oak Woodland

Photo 15: Overview Mitigation Area DG-3A Oak Woodland

Photo 16: Overview Mitigation Area DG-3A Oak Woodland

Photo 17: Overview Mitigation Area DG-3A Oak Woodland

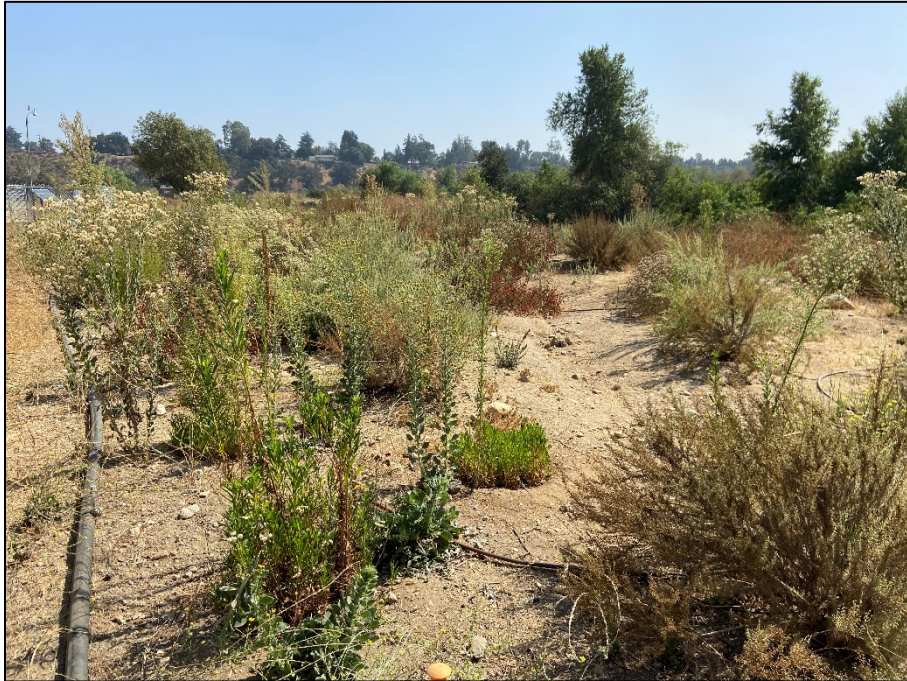
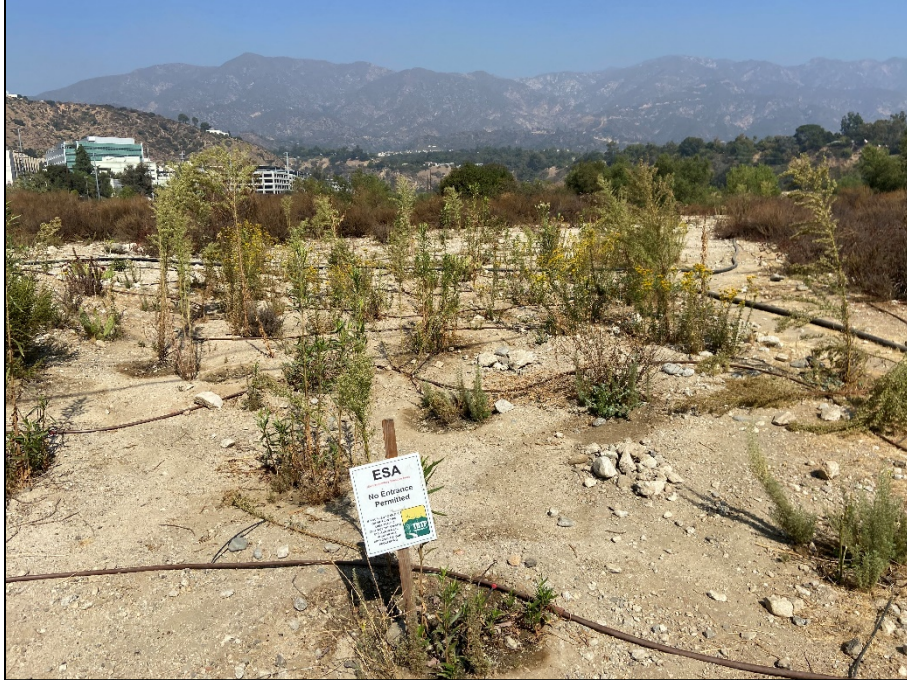
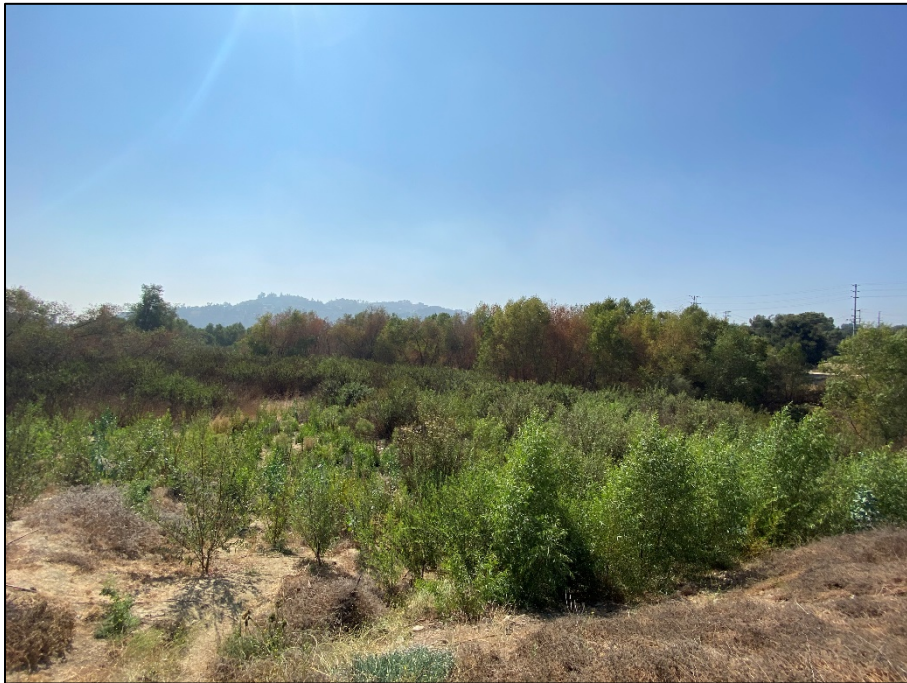
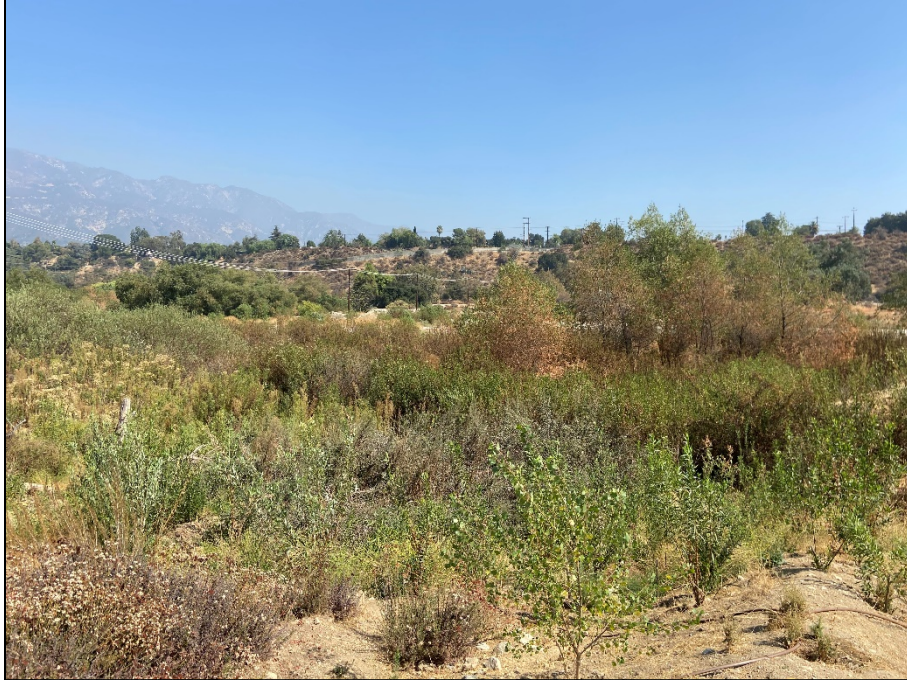
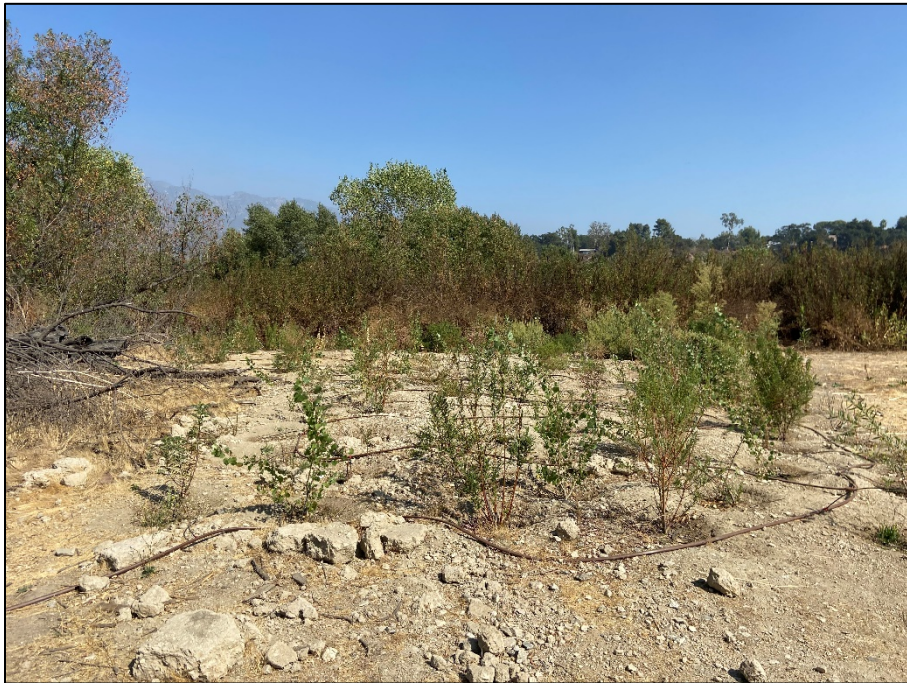
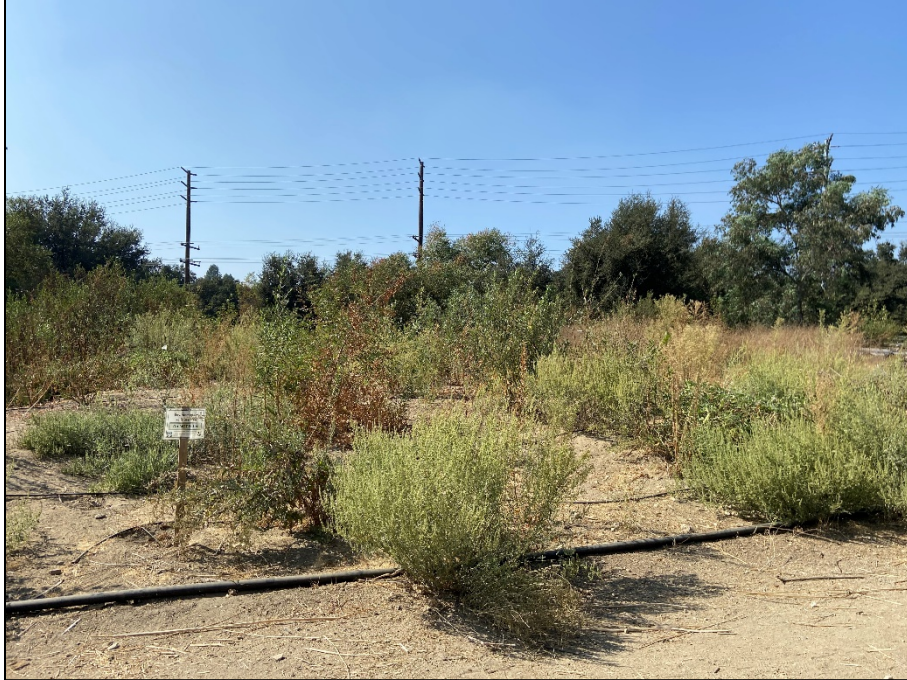
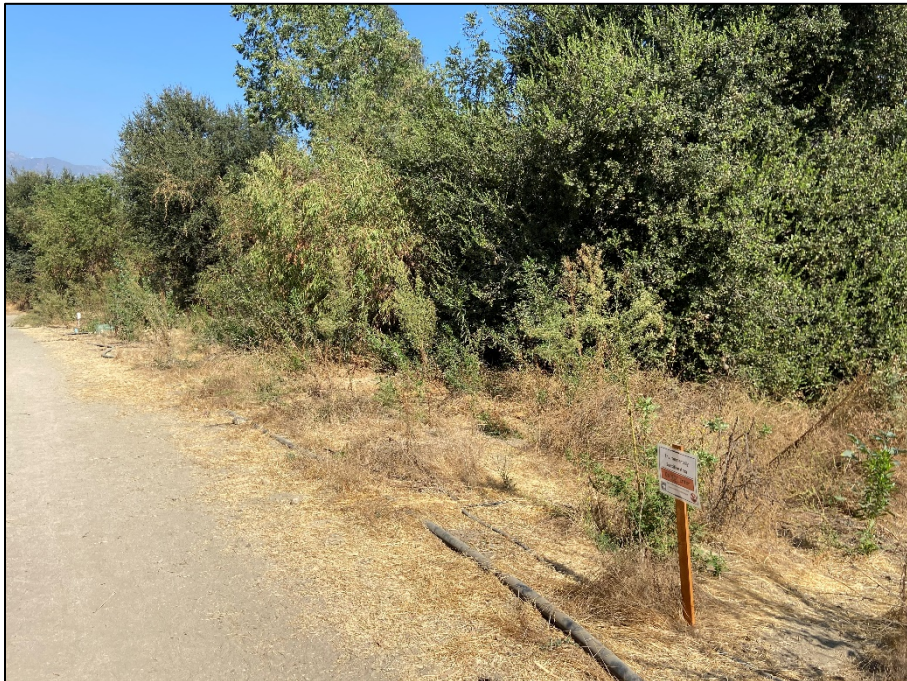
The overall health of the container plants in mitigation area DG-4 was noted as being good. Approximately 20 to 25 percent of container plants in the coastal sage scrub portions of DG-4 were showing varied levels of stress which is approximately 15 percent less than the percentage of plants showing stress during the previous qualitative monitoring event. Approximately 15 to 20 percent of

container plants in the riparian portions of DG-4 were showing varied levels of stress, which is approximately 5 to 10 percent less than the percentage of plants that were showing stress during the previous qualitative monitoring visit. The stress appears to be mostly due to drought stress from recent high temperatures. Many plants that appeared to be stressed during the previous qualitative monitoring event, due to irrigation line malfunction, appeared to be recovering following irrigation line repair. In addition, the 300-foot buffer around a least Bell's vireo (*Vireo bellii pusillus*) nest that affected middle portions of DG-4 has been removed; however, weed proliferation in this area prior to buffer removal likely contributed to plant stress and mortality. For most portions of DG-4, only a negligible number of container plants were noted as being missing or dead. Formal mortality counts were taken for DG-4 during the quantitative monitoring and will be included in the annual reporting. The container planted willow species were showing signs of seasonal dieback; however, the planted willow and mulefat cuttings were also observed to be sprouting vigorously. The installation of plants in the DG-4 mitigation area appears to have been completed successfully and the issues noted during the monitoring are not expected to have an impact on the continued growth of the plants. Photos 18 through 24 in Attachment B document the mitigation area during the monitoring visit.

Nonnative weed cover in DG-4 was estimated at approximately 5 to 15 percent, which is approximately 5 percent higher than what was observed during the previous qualitative monitoring event; however, portions of DG-4 that are adjacent to weed infested portions of Phase 2 (i.e., DG-4A) were observed to have proliferation of perennial pepperweed. Nonnative species observed in DG-4 included black mustard, poison hemlock, perennial pepperweed, horehound, tree tobacco, Indian plantain, and curly dock (*Rumex crispus*). Nonnative weed cover, especially perennial pepperweed, is a significant problem in portions of the DG-4 mitigation area. Because perennial pepperweed can produce dense colonies through seed germination and underground rhizomes (rhizomatous roots), removal of this species without the use of systemic herbicide is very difficult.

Photo 18: Overview Mitigation Area DG-4

Photo 19: Overview Mitigation Area DG-4

Photo 20: Overview Mitigation Area DG-4

Photo 21: Overview Mitigation Area DG-4

Photo 22: Overview Mitigation Area DG-4

Photo 23: Overview Mitigation Area DG-4

Photo 24: Overview Mitigation Area DG-4

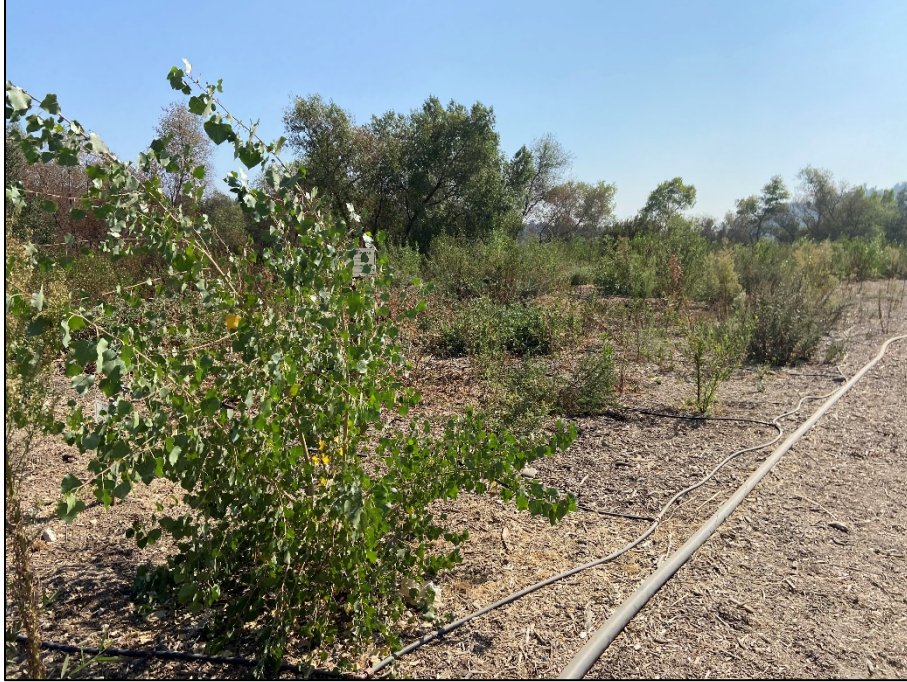
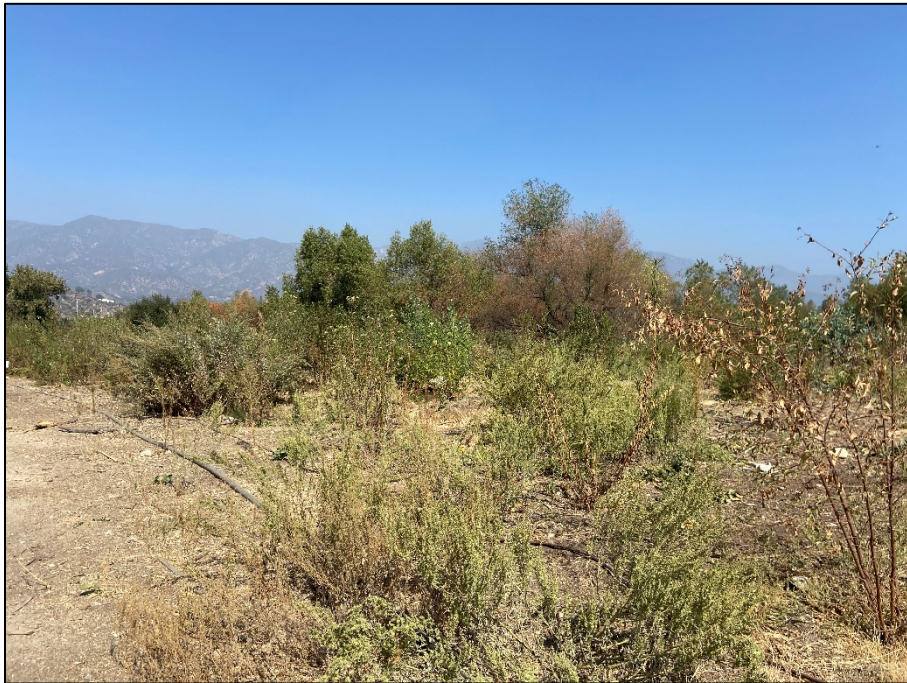
The overall health of the container plants in mitigation area DG-4B was noted as being good and this mitigation area is becoming well established. Approximately 10 percent of all container plants were noted as showing varied levels of stress, which is the same percentage of plants that were showing stress during the previous qualitative monitoring visit. The types of stress the plants were exhibiting are the same as those described for the plants in DG-2A. A negligible number of container plants were noted as being missing or dead. Formal mortality counts were taken for DG-4B during the quantitative monitoring and will be included in the annual reporting. Similar to DG-4, the container planted willow species were showing signs of seasonal dieback. The installation of plants in the DG-4B mitigation area appears to have been completed successfully and the issues noted during the monitoring are not expected to have an

impact on the continued growth of the plants. Photos 25 and 26 in Attachment B document the mitigation area during the monitoring visit.

Nonnative weed cover in DG-4B was estimated at approximately 5 to 10 percent, which is approximately 5 percent higher than the percentage of nonnative cover that was observed during the previous qualitative monitoring event. Nonnative species observed in DG-4B included black mustard, poison hemlock (*Conium maculatum*), and perennial pepperweed.

Photo 25: Overview Mitigation Area DG-4B

Photo 26: Overview Mitigation Area DG-4B

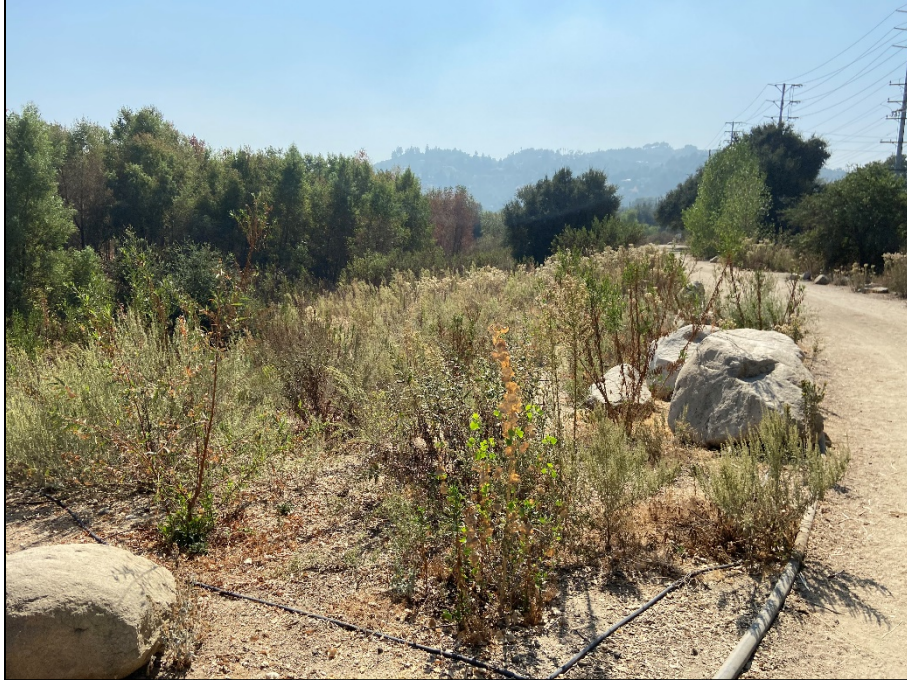
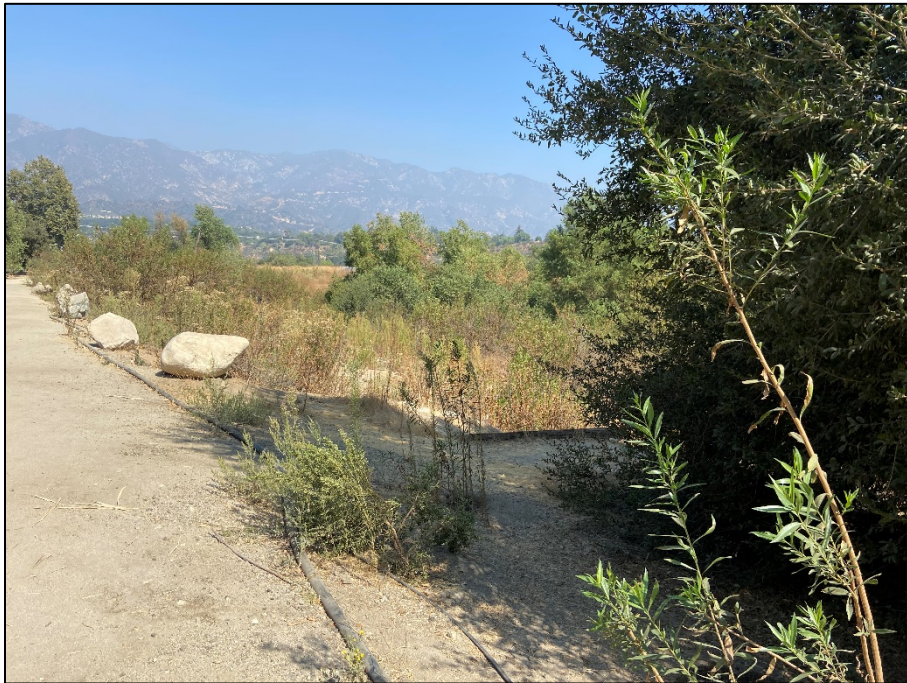
The overall health of the container plants in mitigation area DG-4C was noted as being good. Approximately 10 to 15 percent of all container plants were noted as showing varied levels of stress, which is the same percentage of plants that were showing stress during the previous qualitative monitoring event. The types of stress the plants were exhibiting are the same as those described for the plants in DG-2A. A negligible number of container plants were noted as being missing or dead. Formal mortality counts were taken for DG-4C during the quantitative monitoring and will be included in the annual reporting. Similar to DG-4, the container planted willow species were showing signs of seasonal dieback. The installation of plants in the DG-4C mitigation area appears to have been completed successfully and the issues noted during the monitoring are not expected to have an impact on the continued growth of the plants. Photos 27 and 28 in Attachment B document the mitigation area during the monitoring visit.

Nonnative weed cover in DG-4C was estimated at approximately <1 percent, which is approximately 4 percent less than the percentage of nonnative cover that was observed during the previous qualitative monitoring event. Nonnative species observed in DG-4C included black mustard and perennial pepperweed.

Photo 27: Overview Mitigation Area DG-4C

Photo 28: Overview Mitigation Area DG-4C
