November 12, 2020

Re: *Devil's Gate Reservoir Restoration Project – Phase 1 Restoration Qualitative Monitoring Conducted on October 7, 2020*

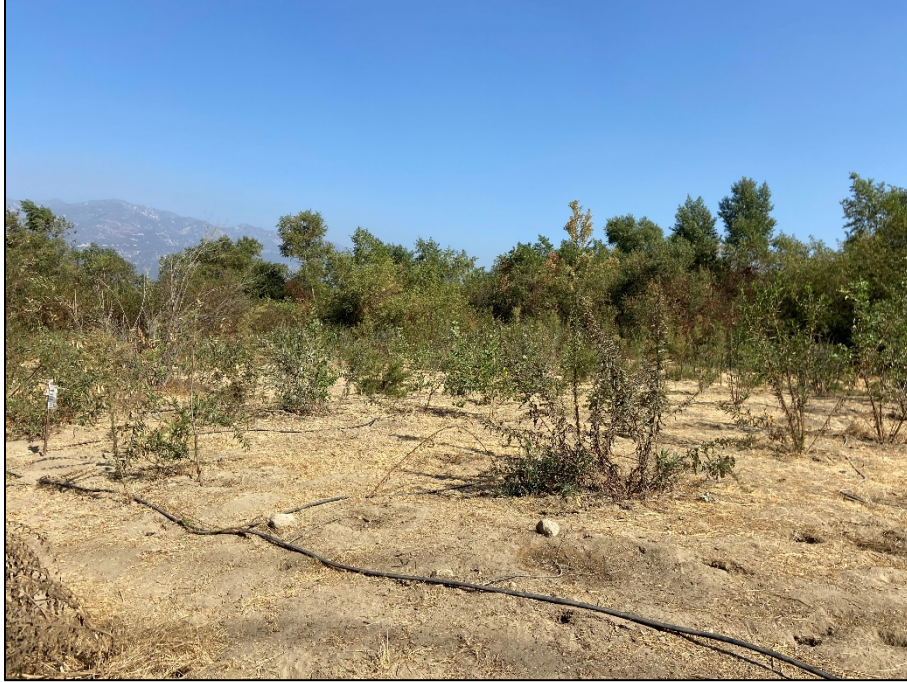
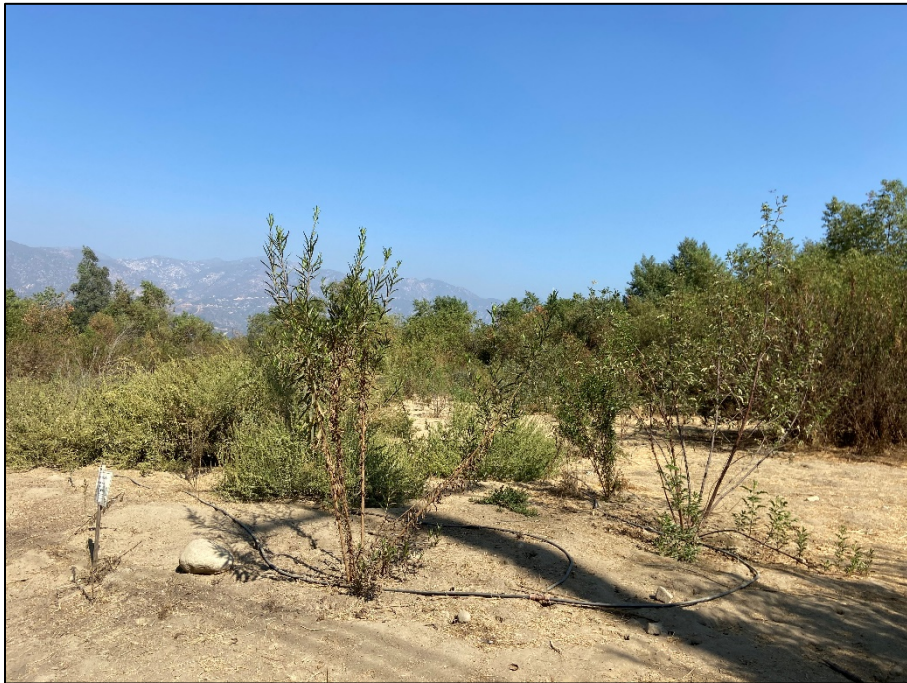
The overall health of the container plants in the DG-5 mitigation area was noted as being good. Approximately 15 to 20 percent of all container plants were noted as showing varied levels of stress, which is the same percentage of plants that were showing stress during the previous qualitative monitoring event. While the 300-foot buffer around a least Bell's vireo nest that affected all of DG-5 has been removed, weed proliferation in this area prior to buffer removal likely contributed to plant stress and mortality. Gopher herbivory is also a significant problem in DG-5 and accounts for the majority of the

missing container plants. Formal mortality counts were taken for DG-5 during the quantitative monitoring and will be included in the annual reporting. Similar to DG-4, the container planted willow species were showing signs of seasonal dieback. The installation of plants in the DG-5 mitigation area appears to have been completed successfully and the issues noted during the monitoring are not expected to have a negative impact on the continued growth of the plants. Photos 29 and 30 in Attachment B document the mitigation area during the monitoring visit.

Nonnative weed cover in DG-5 was estimated at approximately <1 percent, which is approximately 29 to 34 percent less than what was observed during the previous qualitative monitoring event. The decrease in weed cover appears to be attributed to recent mowing of nonnatives in this mitigation area.

Photo 29: Overview Mitigation Area DG-5

Photo 30: Overview Mitigation Area DG-5
